Silicon-Based Ceramic-Matrix Composites for Advanced Turbine Engines: Some Degradation Issues

Linus U.J.T. Ogbuji

Dynacs Engineering Co.
NASA-Glenn Research Center
Cleveland, OH 44122, USA

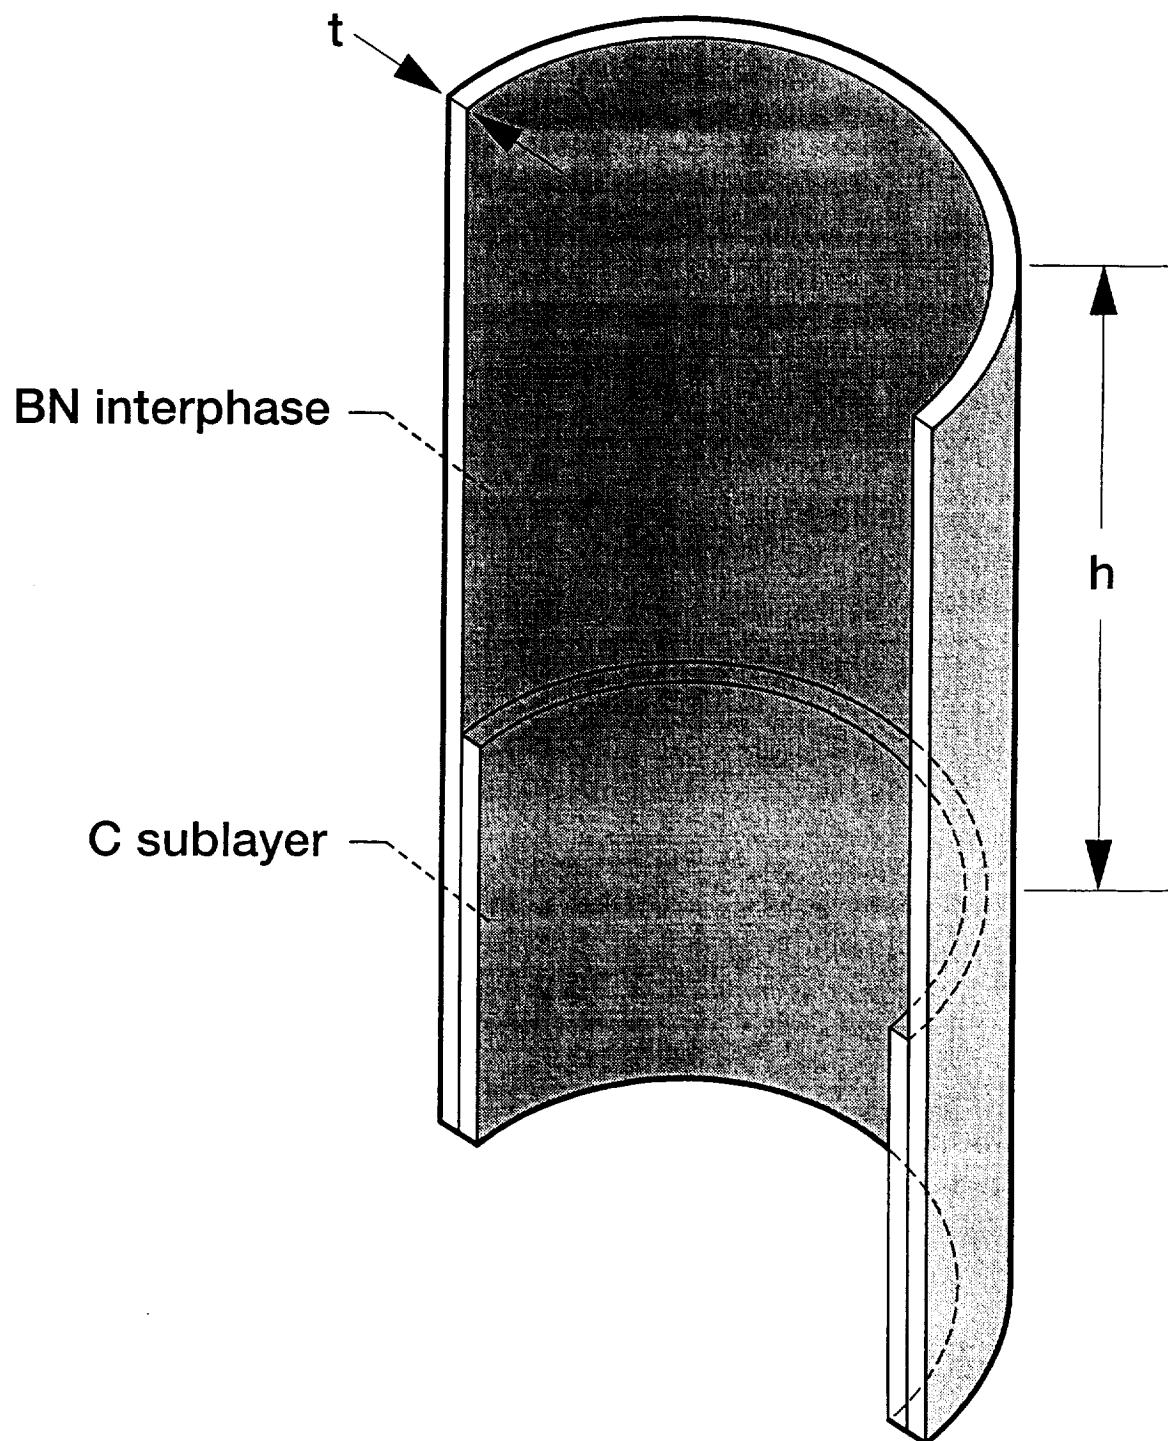
Figure 6 is a schematic illustration of the deleterious configuration in question: a layer of adventitious carbon forming a buffer between a fiber and its BN interphase coating. The oxidatively volatile carbon is preferentially consumed when the exposed fiber end comes in contact with the flame. The BN layer is oxidized more slowly [9]. Consequently, the

carbon layer recedes to a greater depth (h) than the BN layer, exposing the BN layer to increased contact with oxidants. Without the carbon layer the BN is attacked only at the annular end, of area $2\pi rt$ (where r is radius of the coated fiber and t thickness of the BN layer). However, in the presence of a recessed carbon layer, the wall surface of the BN is also available for attack, its area being $2\pi rh$. Therefore, when a film of carbon coats the fiber, consumption of the BN interphase is increased by a factor, F , given by:

Connectivity of the pin-holes indicate that carbon recession is continuous throughout the sample hot zone, a distance of ~ 0.5 inch ($\sim 1270 \mu\text{m}$) while the BN thickness is $\sim 0.5 \mu\text{m}$. Using these values one can see that the value of F is considerable, ~ 25000 . Hence, an adventitious carbon layer increases oxidative consumption of the interphase by several orders of magnitude, with a swift and severe degradation of composite properties as the consequence. The process by which interphase consumption embrittles and weakens the composite has been detailed elsewhere [9]. Briefly, it involves interphase conversion to boria, borosilicate (by oxidative and hydrolytic dissolution of the fiber), and eventually to SiO_2 (by loss of volatile boron hydroxides). The main effect is to stiffen the material with brittle silica welding the fibers down. That alone has been shown to cause pronounced local stress concentration at the weldments [14] and probably accounts for much of the degradation we observed in samples exposed for short times (15 hours), especially at the lower temperature end of the pest regime.

6. A sketch illustrating adventitious carbon film beneath BN interphase layer in a SiC/BN/SiC composite, and the faster oxidation (recession) of the carbon film

The advantages of SiC/BN/SiC composites (over metallic components and oxide CMCs) in turbine engine hot sections are many, but their full benefits cannot be realized until a few lingering issues are resolved. One such issue, pest degradation in an engine flame, is of major concern. However, it appears to be caused by the presence of a process-induced film of adventitious carbon between fiber and interphase hence, rather than by intrinsic inadequacy of the SiC/BN/SiC constituents. That calls for renewed emphasis on the need to optimize CMC processing steps.

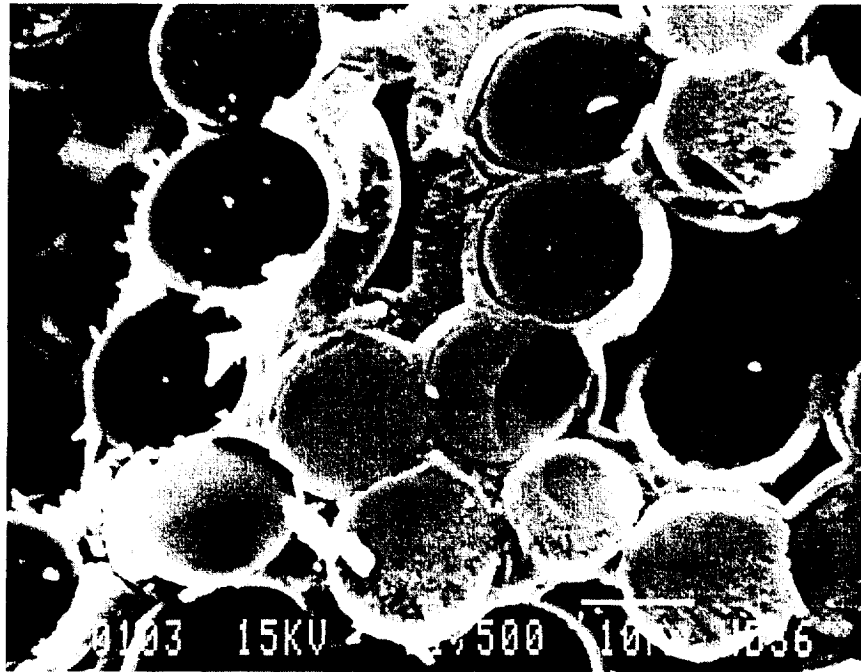
More damage can and does occur when the fibers themselves come under direct oxidative attack, as may be seen in Figures 7 (a) and (b). For the Hi-NicalonTM composite shown in Fig. 7(a), discontinuous attack on the fibers produced the notches at their periphery which arise from localized dissolution of fiber by borosilicate liquid derived from the interphase by oxidation. In the SylramicTM composite shown in Fig. 7(b), attack on the fibers is quite systematic. Oxidation has consumed most of the fiber in Fig. 7(b) as well as the cladding of SiC around the interphase, converting it all to silica (identified by EDS). Only a small

7. SEM fractographs showing effects of interphase oxidation in SiC/BN/SiC systems: (a) in the Hi-NicalonTM/BN/SiC composite, fiber flaws from localized attack; (b) in the SylramicTM/BN/SiC composite, destruction of the fiber by oxidation

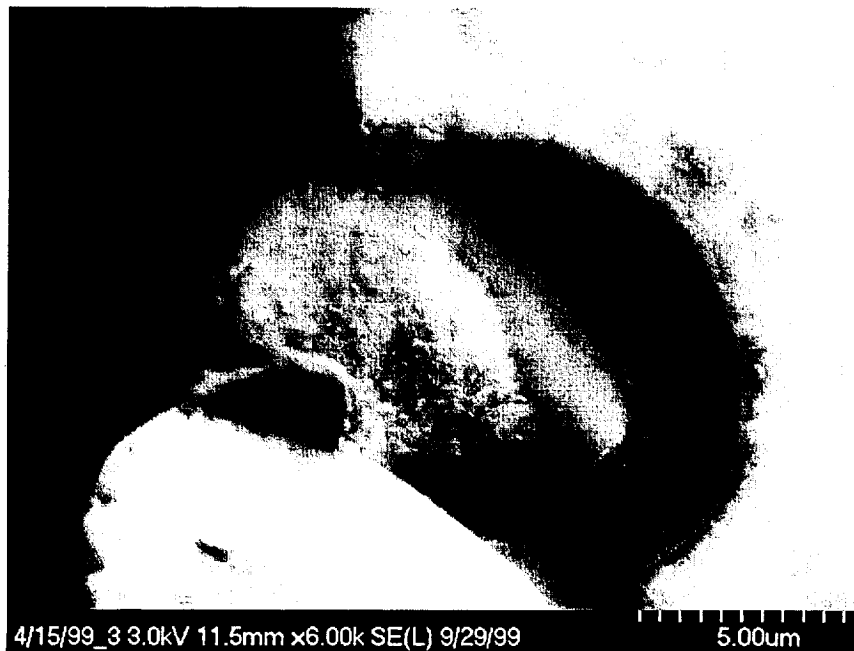
(b)

core of the fiber remains unoxidized. In either case oxidation of the fibers causes very prominent flaws that degrade fiber strength, diminishing its ability to bear load when it spans a propagating matrix crack.
